State-Licensed Disposal Area at West Valley: 2015 Annual Report

Final Report

March 2016

**New York State Energy Research and Development Authority
West Valley Site Management Program**

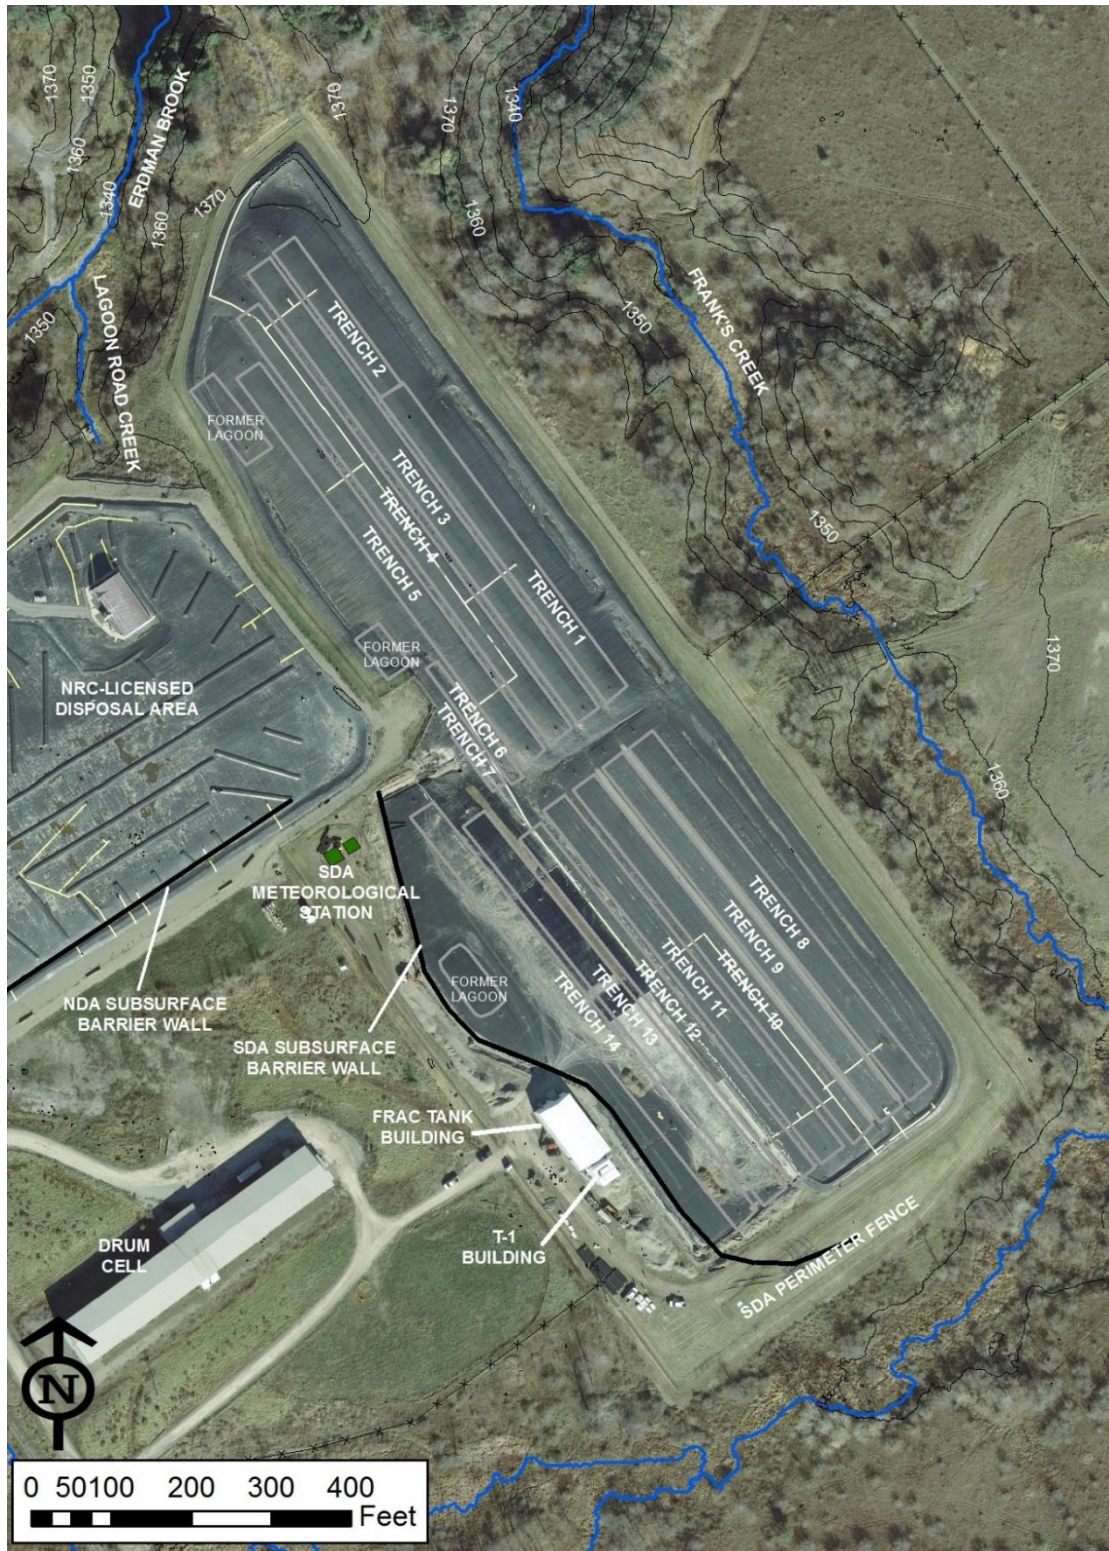
Figure 1-2. Aerial Photograph of the State-Licensed Disposal Area

The SDA occupies approximately 15 acres of the WNYNSC (Figure 1-1) immediately adjacent to the West Valley Demonstration Project (WVDP). The SDA consists of three filled lagoons and two sets of parallel trenches that contain radioactive waste: 1 through 7 in the northern area and 8 through 14 in the southern area (see Figure 1-2). The SDA is surrounded by an eight-foot-high, chain-link fence.

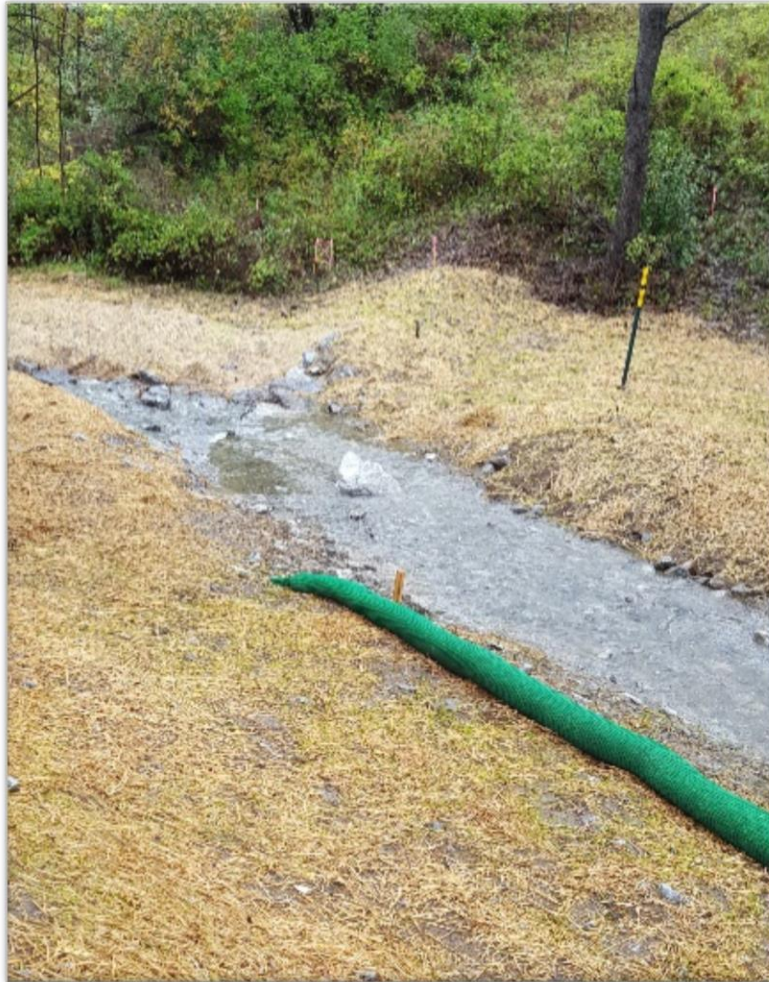
Figure 4-1. Erdman Brook Enhancements and Restoration

Damage sustained during the July storm event to Erdman Brook adjacent to the SDA consisted of minor stream bank scour and a loss of aggregate in the stream channel. NYSERDA had an engineering design completed to restore the area with additional enhancements to aid in preventing future erosion. This work was completed in September 2015. Figure 4-1 shows the completed restoration.

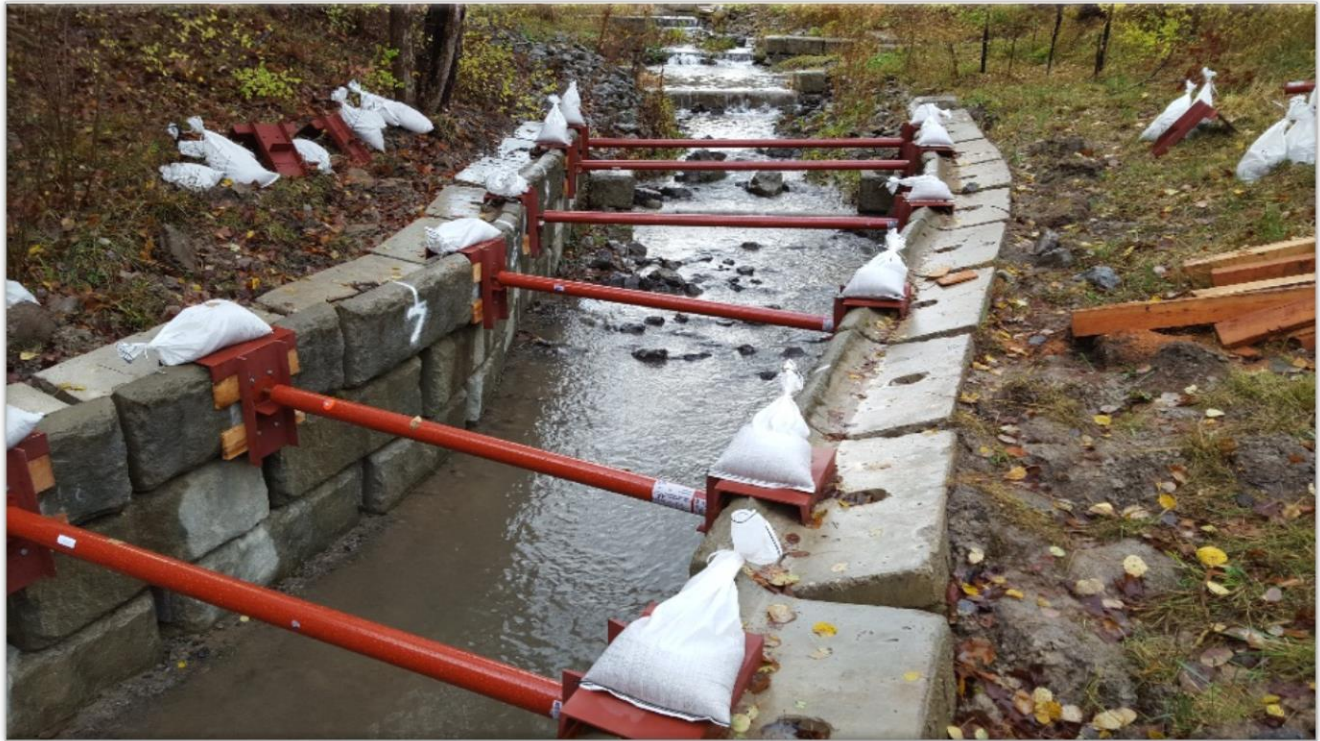
Figure 4-2. Erdman Brook Retaining Wall Temporary Bracing

NYSERDA has been monitoring the retaining wall structure at Erdman Brook from 2013-2015 and has identified that the walls are tilting inward at an increasing rate. NYSERDA is currently working with their former engineering services contractor to develop a mitigative design that can be implemented during the 2016 field season to address the tilting.

As an interim repair, NYSERDA engaged their current engineering services contractor to design a temporary bracing system. The design was installed by NYSERDA's Operations and Maintenance contractor in September and will be replaced by the long-term repair in 2016. Figure 4-2 shows the temporary bracing.

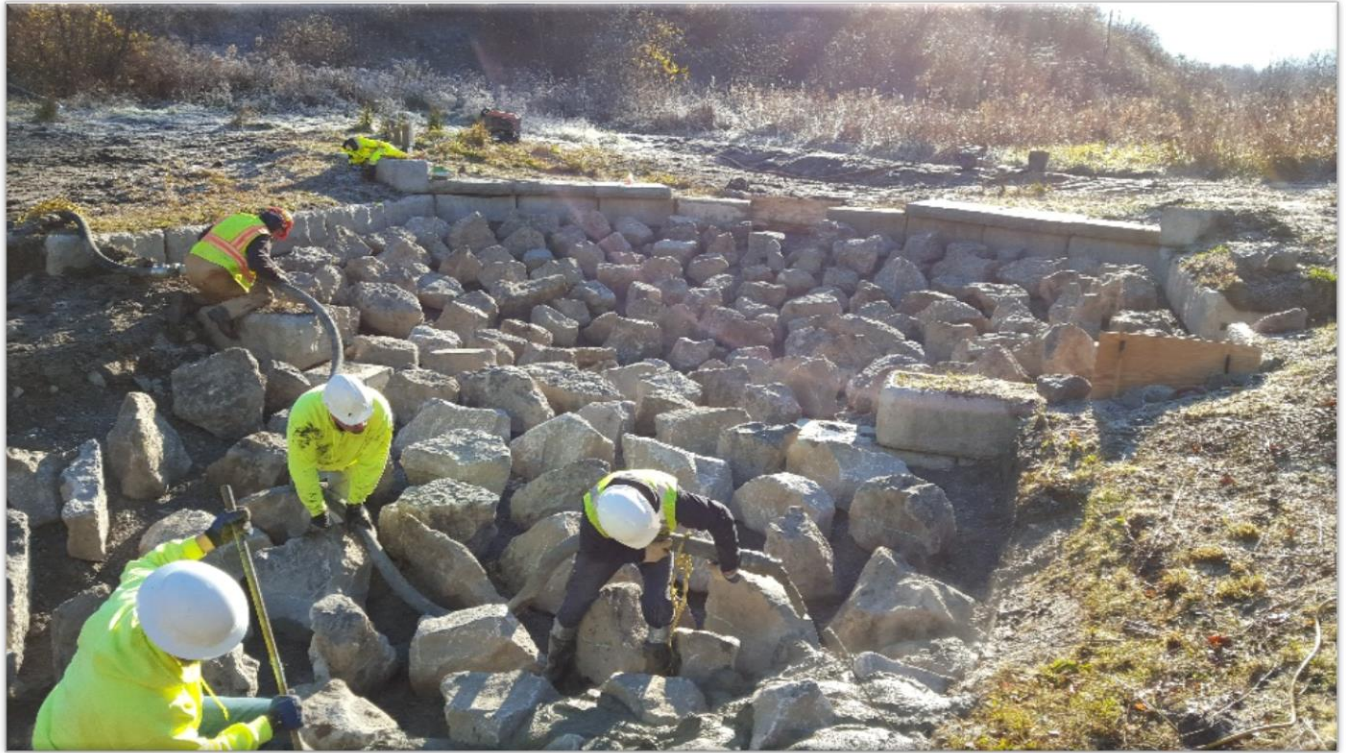
Figure 4-3. Frank's Creek Enhancements and Restoration

The extreme storm event in July 2015 washed out sections of the Frank's Creek erosion controls leaving bare soils prone to erosion. NYSDERDA requested a mitigative design with enhancements from their engineering services contractor, and implemented the repairs by the end of 2015. The new design incorporated the same engineering requirements as the initial design, with the addition of enhancements to the upper plunge pool. (This plunge pool was regraded and lined with medium-sized stone grouted in place to dissipate the energy of the creek.) Downstream check dams and micropools were also re-established to maintain the aquatic habitat. Figure 4-3 shows the Frank's Creek restoration.
